U. S. FOREST SERVICE
RESEARCH PAPER NC-4
JUNE 1966

Effect of Initial Moisture Content on Performance of HARDWOOD PALLETS

● DANIEL E. DUNMIRE

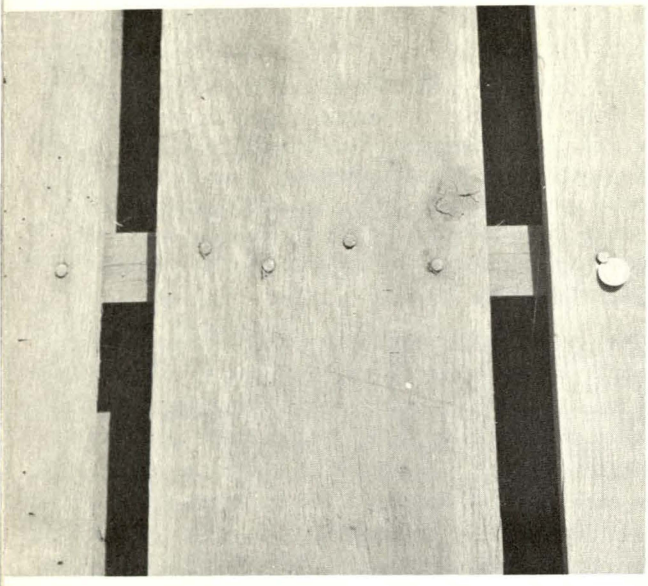
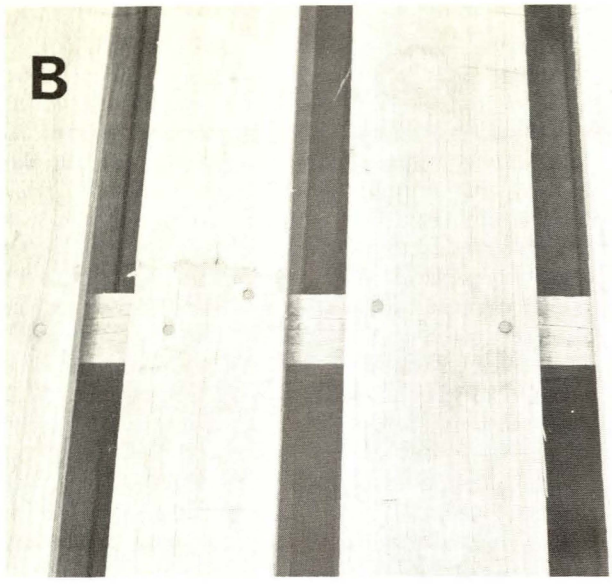
Nail-popping, the projection of nailheads above the surface of the deckboards due to shrinking of stringers, was prevalent in pallets made with green stringers. It did not occur in the pallets made with dry stringers (fig. 2). Nail-popping developed during the early stages of the test while the green stringers were drying. Most nail-popping was slight and it was not regarded as a serious defect in this study.

FIGURE 2.— (A) Nail-popping in an all-green pallet because of stringer shrinkage; (B) no nail-popping in an all-dry pallet because stringer did not shrink.

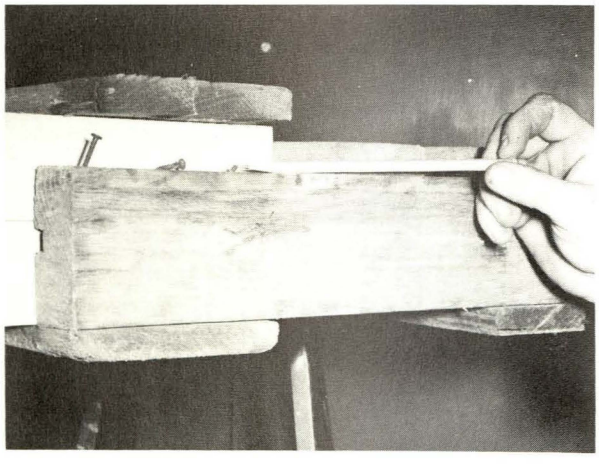
FIGURE 3.— Edgeboard separated from stringer. Leading nail (left) pulled through the deckboard. Pencil points at nail on inside edge of deckboard that sheared off.

Most often, particularly in the early stages of the test, edgeboards failed by coming loose from one or more stringers. When an edgeboard split at the nails, the nails usually pulled through the board. If the edgeboard was not split, the failure was usually because the nails sheared off between the stringer and the deckboard. Those nails closest to the leading or outside edge of the edgeboard most often pulled through, while those nearest the trailing or inside edge usually sheared off (fig. 3). Failure of the nails at the center of the joint was about equally divided between pullthrough and shearing.

When splits were present at the nails in edgeboards, the prying action of lift-truck forks caused the leading-edge nails to begin pulling through the deckboard. This increased the load on trailing-edge nails

and tended to shear them off. Since splits were more prevalent at nails in green deckboards (table 3), failure occurred most often in pallets with green decks.

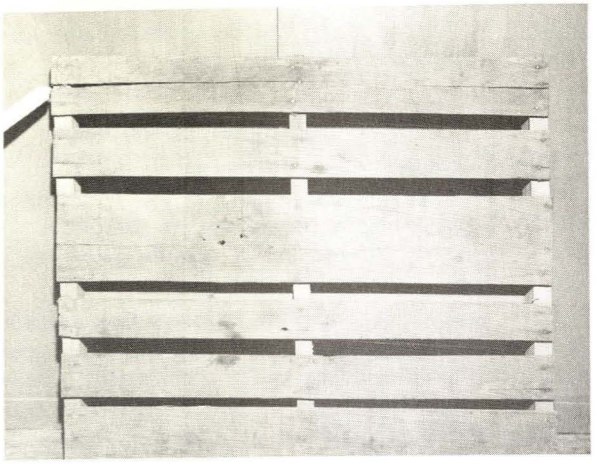
In some cases edgeboards split from end to end and one or both halves of the edgeboard broke away from the stringers (fig. 4). These end-to-end splits developed gradually from short splits at the nails after repeated bumping and pushing by lift-truck forks. When splits (following cross grain) extended to the leading or trailing edge of the board, a wedge-shaped piece often broke off (fig. 5). After 4 years the number of wedges broken off the edgeboards averaged 3.1 per pallet for all-green pallets, 1.5 per pallet for all-dry pallets, and 1.9 per pallet for dry-green pallets. Wedge breakout did not cause edgeboards to be rejected or necessitate repair of the pallet.

FIGURE 4.— Lengthened split causing edgeboard to split into two parts.

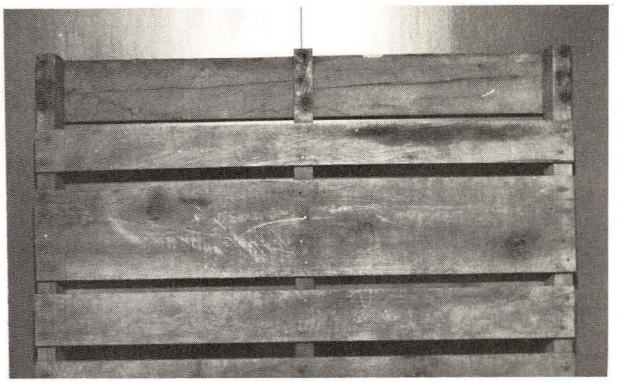
Another type of splitting started in checks that developed in the bottom deckboards during the third year of the test. Long, deep, continuous checks developed on the upper face of many bottom edgeboards and wide interior deckboards (fig. 6). These checks sometimes extended the full length of the board. After the fourth year they were equally frequent and severe in all pallets regardless of original moisture content. In all-dry and dry-green pallets,

We believe this defect was caused by tension stresses in bottom deckboards that absorbed moisture from the floor causing the bottom face of the boards to swell while the upper face remained dry due to airflow across it. Cupping of the boards did not occur especially in all-dry pallets, because the boards were firmly nailed. Though these checks caused no failures during the 4-year test, it is likely that many boards eventually will fail because of them.

FIGURE 6.—Long, deep, continuous checking on upper surface of bottom edgeboard.

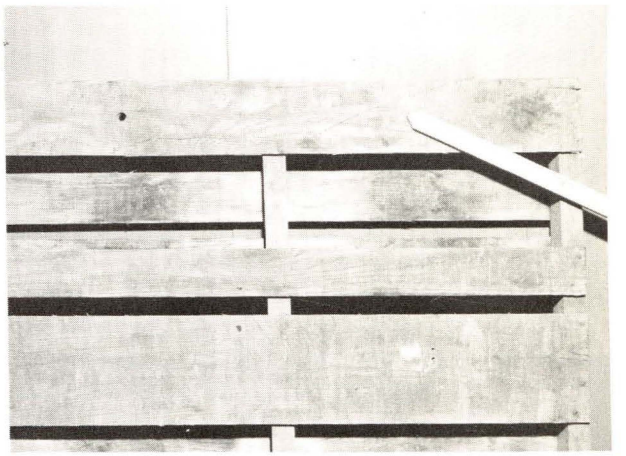
these checks averaged 34 inches in length, while in all-green pallets they averaged 37 inches in length. Oftentimes these checks extended through the board and developed into splits (fig. 7).

FIGURE 7.— Deep checking on upper face of bottom edgeboard has developed into a split on the bottom face. From left to right pointer indicates length of split.

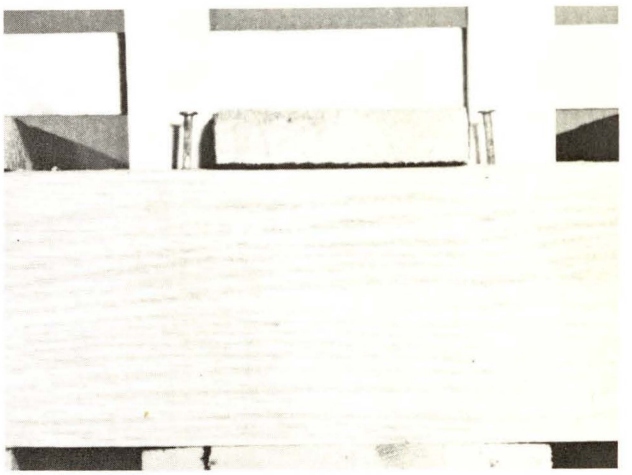
FIGURE 9.— Outer nails leaning 3 degrees toward board center in pallet that has not been moved by a fork truck. Lean is due to board shrinkage.

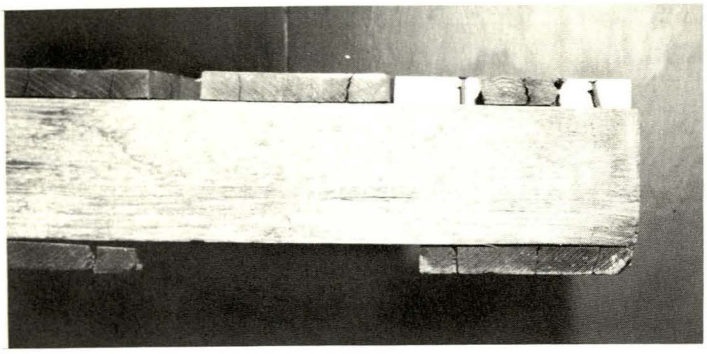
The pattern of nail bending in pallets in use was altered by repeated impacts from fork trucks. This was indicated by the difference of nail bending in the pallets that were service tested. In some pallets the leading nail bent about 5 to 6 degrees towards the center nail in a 3-nail edgeboard joint (fig. 10), but the trailing nail remained almost erect. The increased bending of the leading nail was evidence that the fork truck pushed the edgeboard back slightly, therefore increasing stresses at the leading nail and causing splits. When the grain sloped towards the leading edge, wedge breakout occurred. In pallets with dry deckboards most nails remained almost erect, thus indicating there were no serious stresses at nails.

FIGURE 10.—Leading nail bending 6 degrees toward board center in pallet that has been moved about 277 times by fork trucks. Lean is due to impact loading and board shrinkage. Trailing nail is almost erect.
